OTAC R	eplacement Wor	k Instruc	tion
Tools required: Tools		er	 Pliers E-clip Tool (size 5)
Prerequisite			
Removing the OTAC Unit			
		1.	Open the OTAC Assembly by depressing the Lid Latches at both ends.
		2.	Use a cloth (or similar) to cover the gap in the lower chassis, to prevent the e-clip from falling into the chassis, then remove the E- clip using small flat screwdriver.
		3.	Repeat for the right end, again making sure to use a cloth to prevent the e-clip falling into the chassis.
		4.	Slide a piece of paper under the Guide Plate Hinge, to prevent the T20 screw falling into the chassis while removing it from the side plate.

HD Ultra X Series Instructions

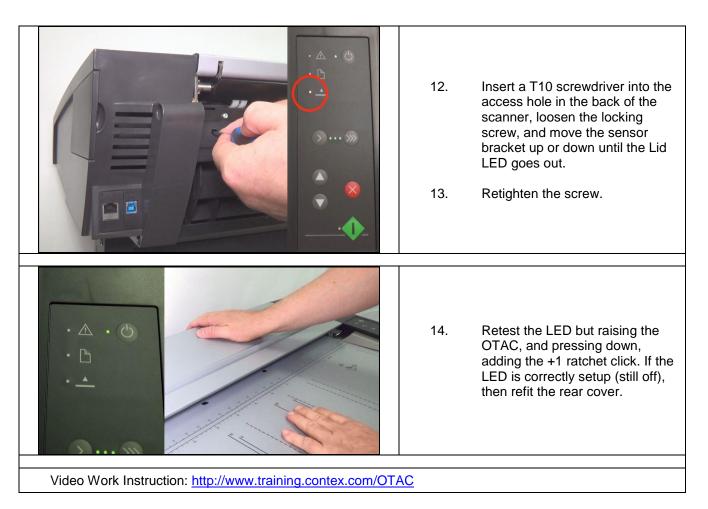
8.	Retighten the 3 x T10 locking screws to hold the Lid Cover down and in place.
Contraction of the second seco	9.	Press down on the Guide Plate until both ends lock in place to close.
	10.	With the scanner powered up, and the OTAC pushed down, with the added +1 click on the ratchet, make sure the LED for the raised lid is off.
	11.	If the LED does NOT go out when the OTAC is closed, then remove the rear panel to access the sensor, to make adjustments. Remove the T10 screws and lift the rear panel off from the back of the scanner.
